Moss Building Water Infiltration

Ellington Agricultural Center

Programming Verification Report

August 26, 2018

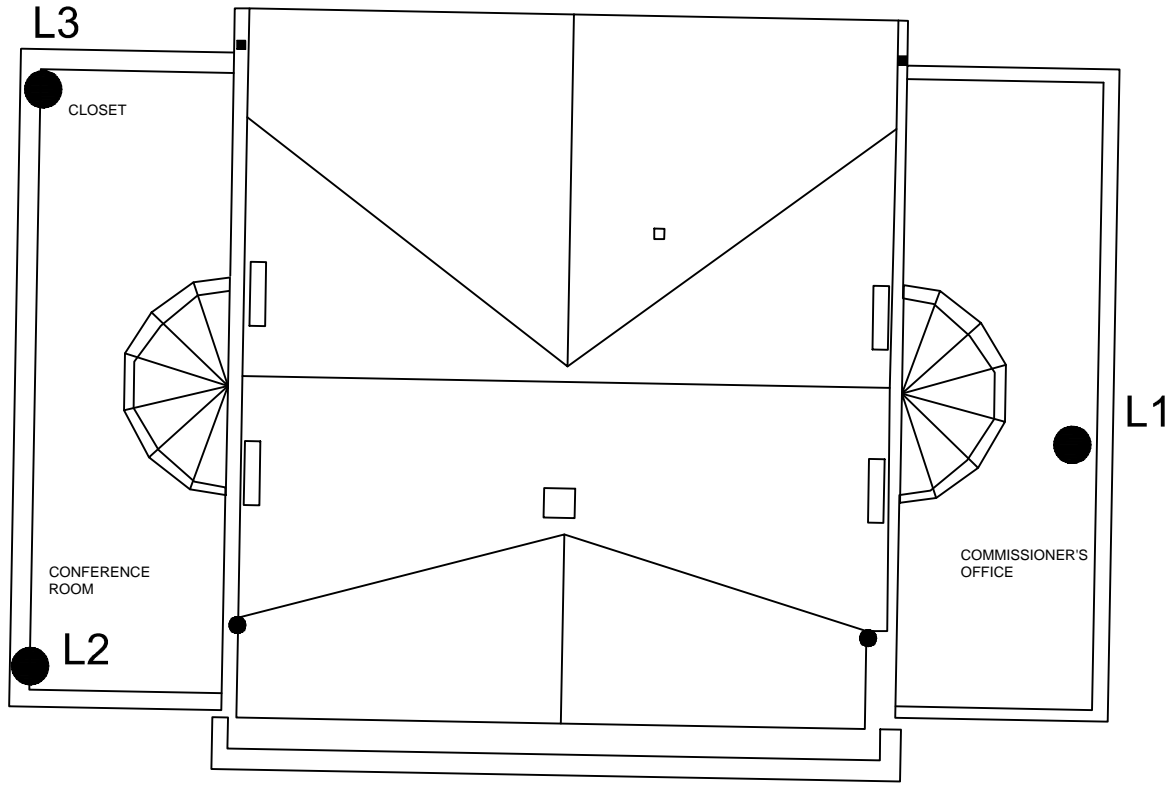
D2 LEAK LOCATIONS
D2 MOSS BUILDING, ELLINGTON ARG CAMPUS

- a) Reportedly for more than six years there have been four major roof leaks which have affected the interior finishes of the building. Each of these leaks are located nearby a roof scupper, in each of the four corners of the building. In all cases, the water has leaked above the plaster ceiling and infiltrated the building and caused damage to the ceiling, walls or decorative crown moldings immediately below the scupper. See *photos 17-23 and 30-34*.

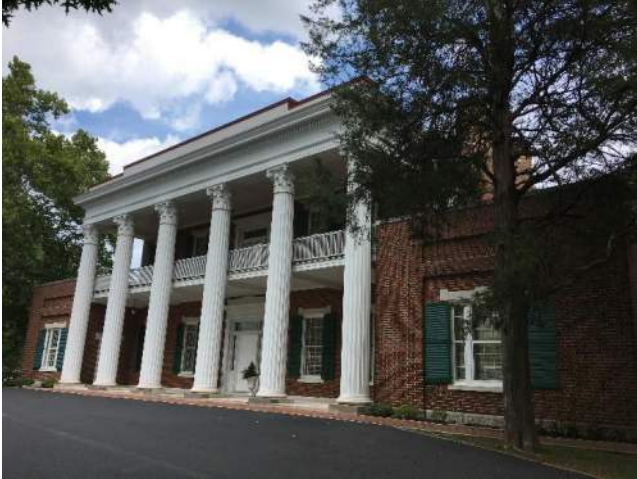
Photo 1

- 1) The Moss Building is located at the Ellington Agricultural Center in Nashville, Tennessee. The 2 story building was reportedly constructed in 1927 and has been renovated over the years to house the offices for the State of Tennessee's Department of Agriculture Commissioner, Budget, Human Resources, and Public Affairs representatives. The structural frame of the building consists of conventional "stick-built" post and beam wooden members. The roof system includes wood plank decking, 2"x6" timber roof trusses, covered with metal panels and small portions of EPDM membrane. The vertical walls include post and beam construction of multi-wythe brick masonry. The interior finishes consist of plaster and lathe at ceilings and walls. There are pre-cast concrete lintels and sills at the windows. There are four square brick chimney structures located at the north and south sides of the building near the high ridge point of the standing seam metal roof. The chimneys extend above the upper roof level and each are covered with decorative copper caps. There are second story covered porches on the front western side and back eastern side of the building with six large columns on each side with decorative architectural capital and leave pattern volutes above the neck of the column. *See photos 1-14 and 250-251.*

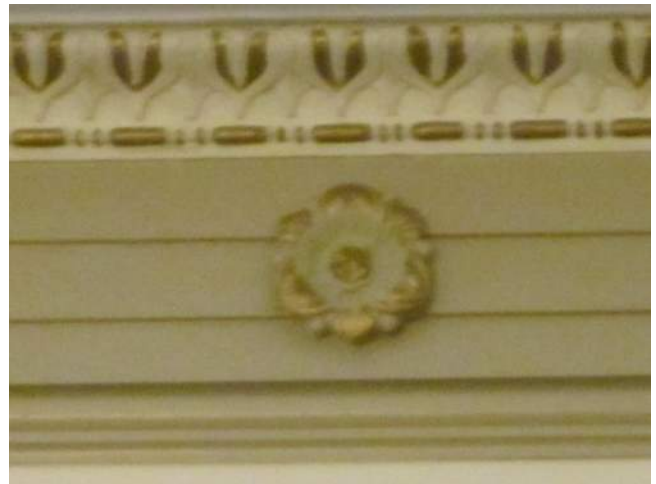
Photo 16

- a) The interior finishes of the building include plaster and lathe. The office areas, conference room and the commissioner's office have detailed ornate patterns that serve as a custom formed plaster crown molding. This detail reportedly matches the original construction of the home in the early 1900's and serves to preserve the historical character of the building. There is water damage to the interior finishes at all four corners of the building. See *photos 15-16, 24-29, 252-262*.

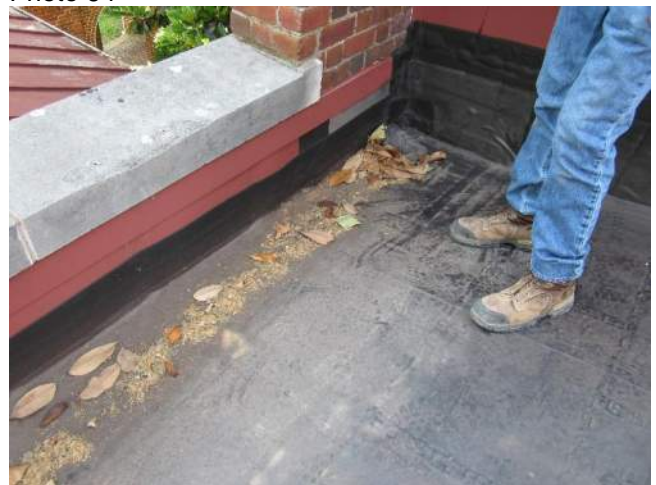
Photo 66

- 5) The building has two lower roof sections located on the north and south elevations of the building. These roof systems are mirror images of each other and are approximately 1,189 sf in size. The majority of these roof sections are covered with the same standing seam metal roof system as the upper roof section. Like the upper roof, and as part of the roof construction, the lower portion of the existing flat soldered seam metal panels were left in place. However in 2014, in an attempt to solve water infiltration issues, an EPDM membrane was installed above the original metal panels and up onto the parapet walls. It appears that several attempts have been made to control the water entry. In some locations, the top and bottom seam connections for the metal panels have been covered with a white elastomeric coating. In other areas, patches of uncured black colored EPDM cover strip were applied over the top seam joints and lower panel connections of the metal roof system. These repairs did not seem to correct the water infiltration issues in these areas and were not successful at maintaining or matching the aesthetic of the other metal roof systems or the requirements by the Tennessee Historical Commission (THC) to be followed on this historic site. *See photos 62-97.*

- g) Storage Closet: Another leak has occurred at the northeastern corner of the building in the ceiling of the storage closet. This leak is immediately below the location of the parapet wall at the scupper. Here the scupper is located in the corner on the horizontal field area of the roof immediately in front of the base flashing. See *photo 66 and 181*.

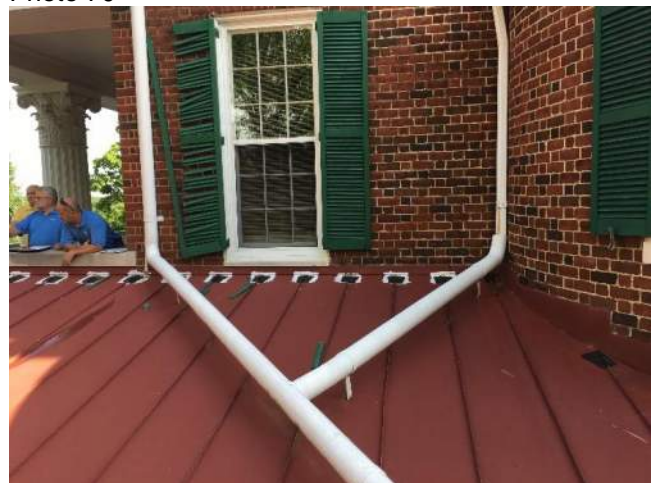
Photo 72

- b) Although the leaders from the upper to lower sections are large enough to handle the isolated flow of each scupper, the stark white appearance of the piping does not match the overall aesthetic of the other roof components which does not meet the goals of the Tennessee Historical Commission of maintaining an appearance typical of the original construction. See *photos 72 and 94*.

- 1] Remove all round drainage piping leading from the upper roof sections and the downspouts of the semicircle gutters so that the drainage discharges directly onto the lower roof sections. Install scuppers in the lower roof sections will be designed to accommodate the drainage from the upper sections of the roof.

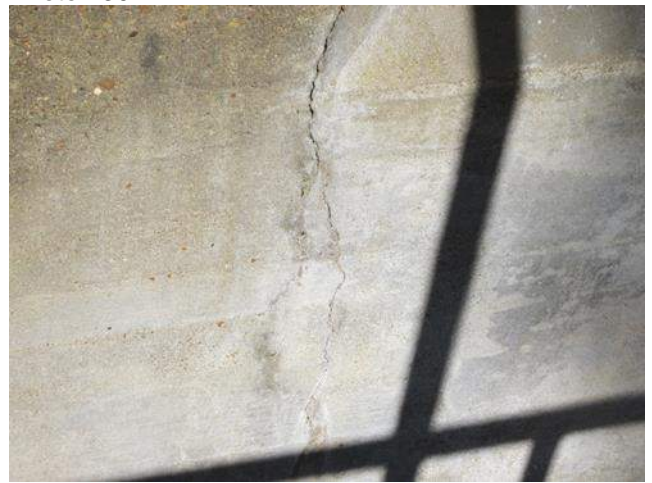
Photo 132

- c) There are cracks along concrete block wall which leads down the exterior basement steps. *See photo 132*
- d) There are some surficial horizontal cracks in the masonry near the foundation at the stairwell and base of the columns in the connector building archway next to the northeast corner of the building. *See photo 135.*

- 3) Repair the existing exterior brick mortar joints and any cracks in the masonry block walls or other precast concrete. Repair by filling all voids, tuck pointing as needed, and removing and replacing any broken pediments. Repairs will be done using a mortar that matches the profile, color, and consistency of the original mortar and is aesthetic of the masonry and preserve the historical requirements for the windows.

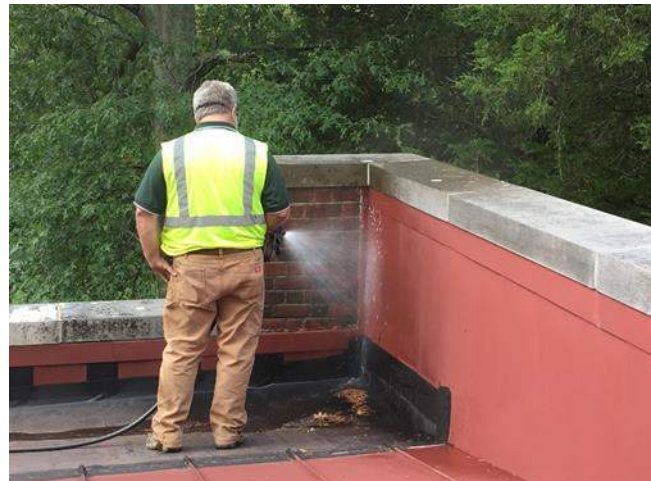
Photo 144

- c) Water tests were conducted over the Commissioner's office. Although the leakage path was not recreated in this location, there are temporary measures in place by the facility managers to redirect water and we are confident that the leakage in this location is similar to the leakage path documented in other similar locations during the field work. The roof conditions above this area include a patchwork of components with multiple suspect transitions that leaked in other test areas including around the scupper opening, and that do also not lap over the top of the parapet wall. See *photos 144-153*.

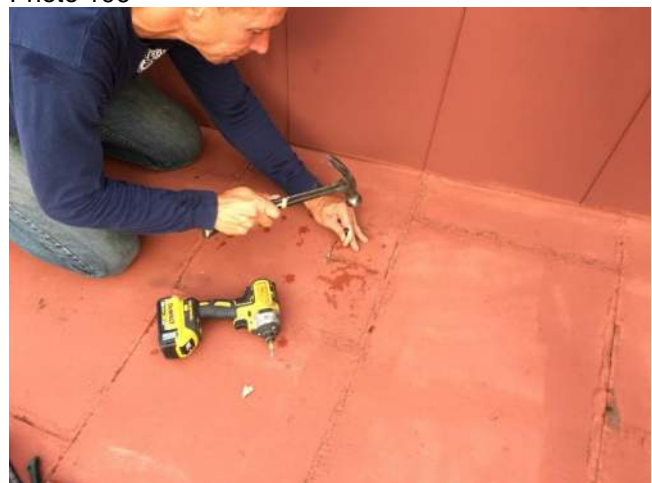
Photo 198

- 3) Core test were performed in order to determine the exact construction of the upper roof section. A sample was taken through the existing original flat metal panel. The test revealed that the metal panel had been installed over a layer of red rosin paper, and over an asphaltic ice & water shield, directly over the wood plank decking. The core sample also revealed that the red rosin paper was wet and there was a small amount of water between the bottom of the metal panel and the top of the rosin paper. There was some evidence of deterioration on the wood plank decking, but most of the deck was in good condition. The conditions indicated that the asphalt underlayment has been protecting the wood decking and forcing the water to the low-slope area near the base of the wall by the parapets and the scupper drain boxes. *See photos 198-206.*

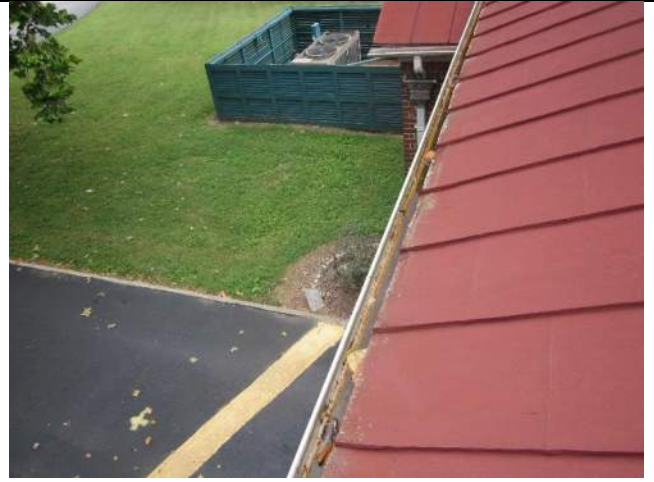
Photo 232

- 9) Directly adjacent to the Northeast corner of the lower roof section, there is a canopy connector archway leading to a stand-alone building. Both the canopy roof and stand-alone building's roof consist of older sloped flat-lock soldered seam metal roof panels with external gutters and downspouts. Adjacent to the stand-alone building to the northeast, is a covered walkway leading to another building. Both the covered walkway and building to the north of the Moss Building have newer metal standing seam roofs that were recently installed. See *photos 231-236*.

- f) The existing flat-lock metal panels over the semicircle (turret roof) bay areas, the connector archway, and the stand alone adjacent building will be removed and replaced with a new metal standing seam roof system that includes the appropriate underlayment, cover board, step flashing and new oversized guttering.

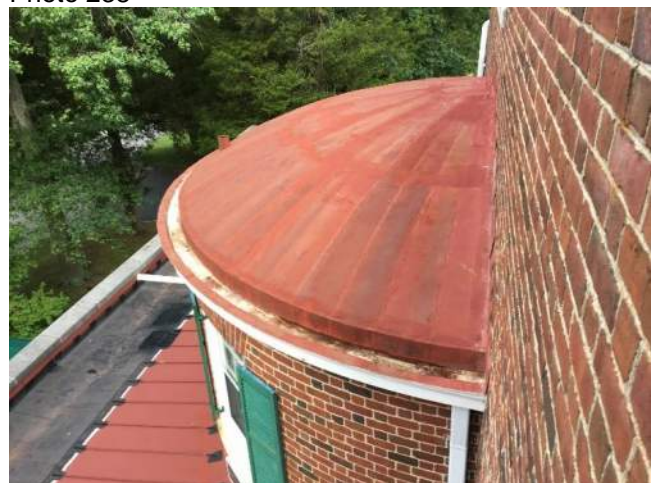
Photo 240

- 4) The building has two semicircle shaped building sections extending out from the main building, located at the center of the north and south elevations. These sections consist of brick walls with bay windows and are covered with an older flat soldered seamed metal turret roof system and the age of this system is unknown. Each of these sections has a semicircle gutter along the roof edge and have a downspout that leads down to the lower roof sections. *See Photos 237-240.*

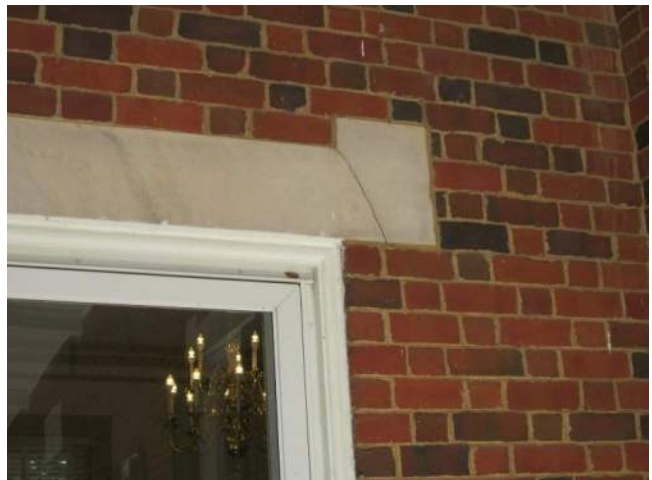
Photo 246

- b) Many of the existing pre cast concrete window header lintels have vertical cracks through the lintel. The cracks extend through the entire thickness of the pre cast lintel but do not extend beyond the lintels to the exterior brick, *See photos 243-247*

- 4) Perform structural repairs to cracked pre cast concrete window lintels using a structural epoxy injection repair to stabilize and strengthen the window header lintels. The injected crack will then be sealed with an appropriate mortar or grout to match the look of the pre cast concrete.
